Division of Oil, Gas and Mining

Minerals Inspection Report

Mine Name: Gardner Canyon/Nebo Gypsum	Permit Number: S/023/0015	Mine Status: Active
Operator Name: Triumph Mining Corporation	Inspection Date: 07/29/2015	Permit Fees: Paid
Inspector(s): Wayne Western	Inspection Time: 11:00 am - 1:30 pm	Bond Amount: \$40,000
Attendee(s): George Garcia, Renee Flanagan, Roger Kesterson	Weather: warm and clear	Bond Escalation: 11/14/2015
Inspection Purpose: Routine inspection		Prior Inspection: 08/30/2013

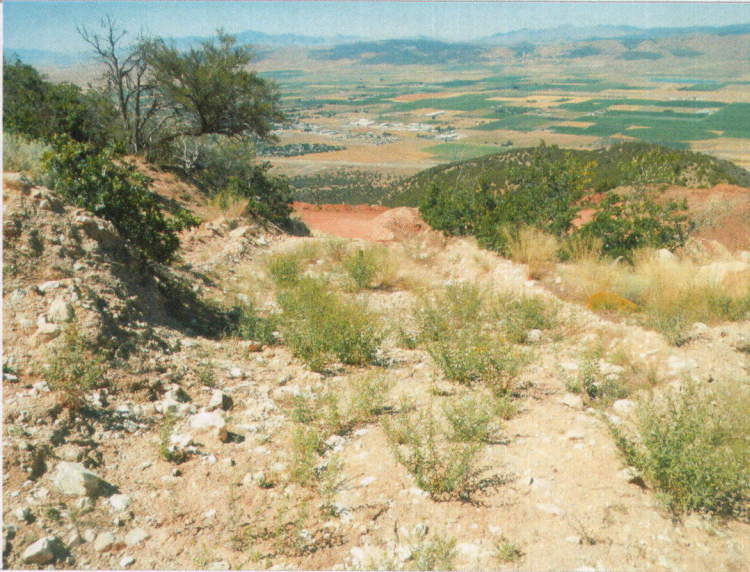
Road east of disturbed area boundary near pit looking south west

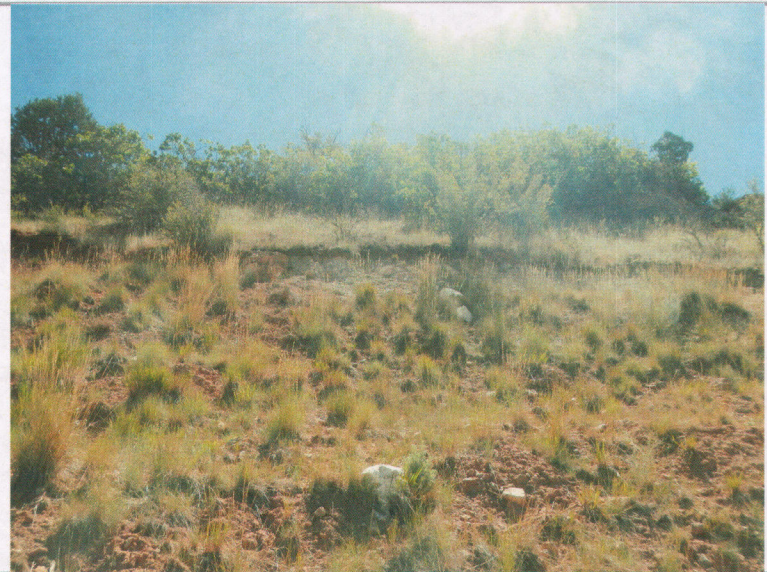
Road east of disturbed area showing reclaimed cut slopes looking east

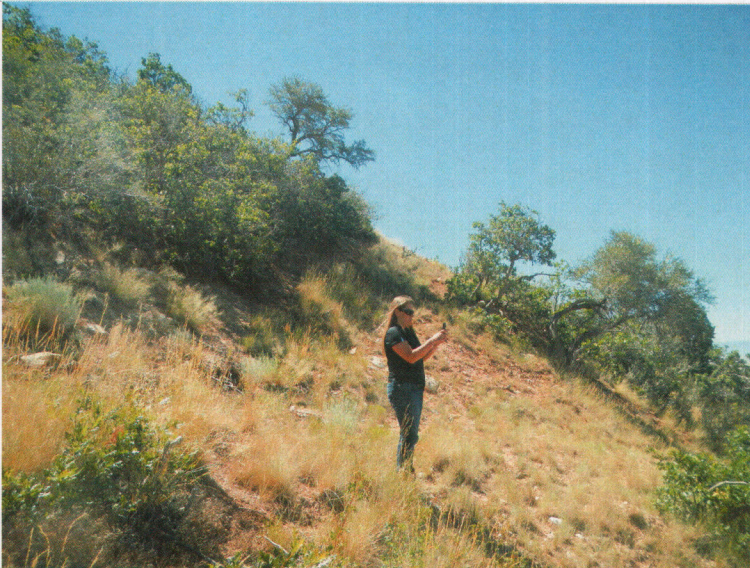
Road east of disturbed area looking south

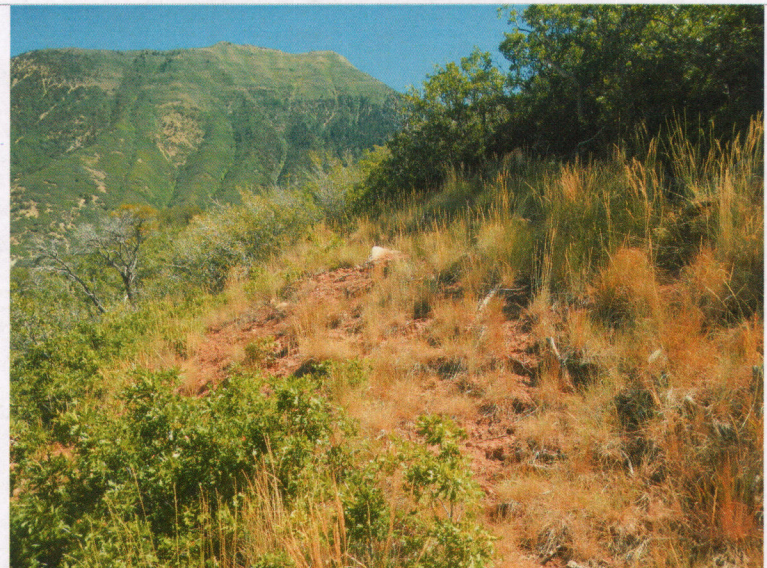
The Operator did re-vegetate the road that was constructed east of the pit. The Division should have a biologist determine if the vegetation meets minimum standards.

Road east of disturbed area looking north. Areas has been revegetated.

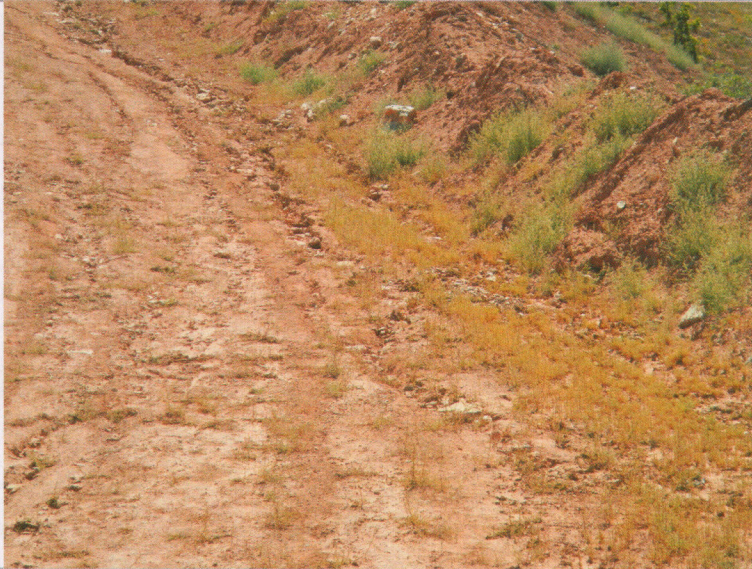
3.	Protection of Drainages/Erosion Control There are rills in the roads within the disturbed area boundaries. The rills are large enough to make driving on the road difficult, and if not checked the roads could become non drivable.	<input checked="" type="checkbox"/>	<input checked="" type="checkbox"/>

Rills on road near top of the pit

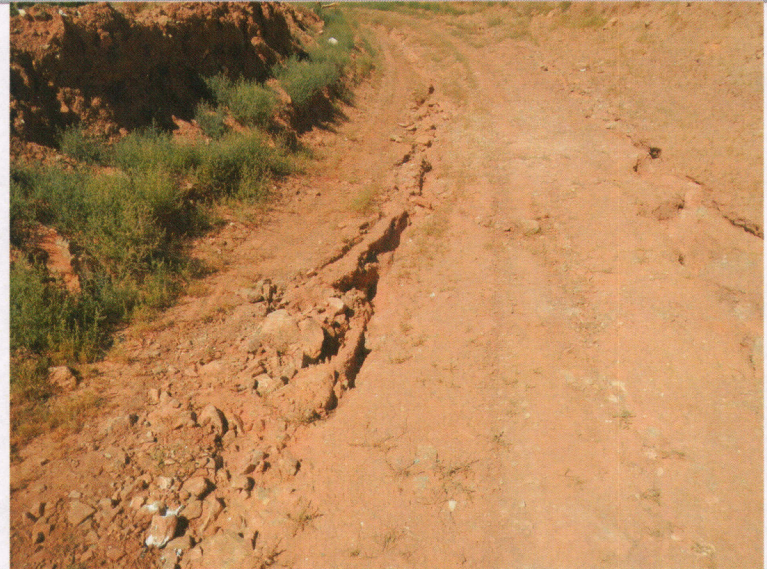
Rills on road looking west

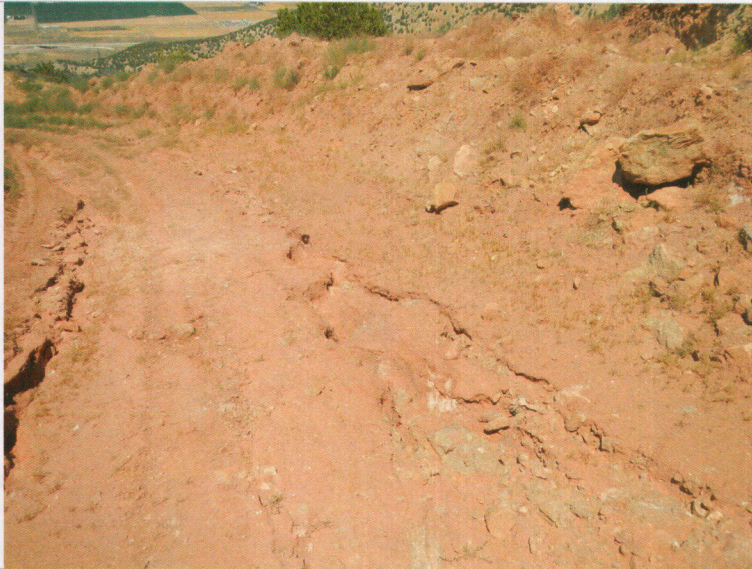
Rills on road looking west

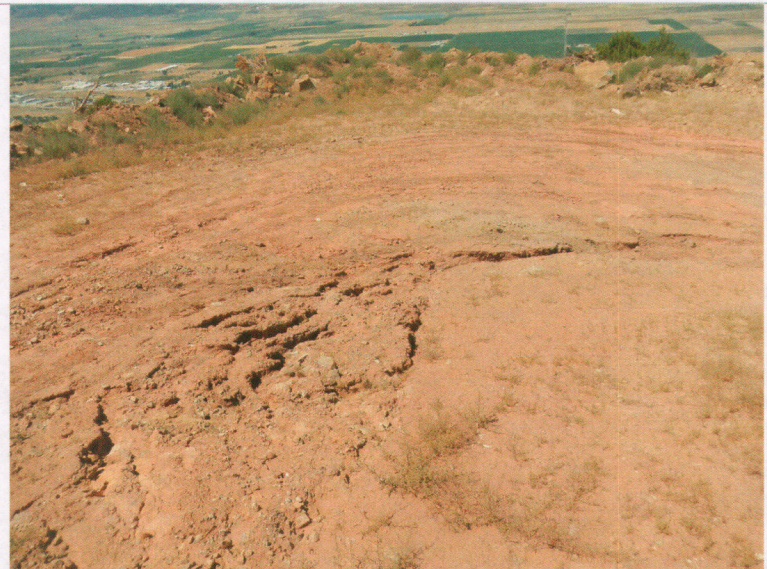
Rills on road first turn from pit area

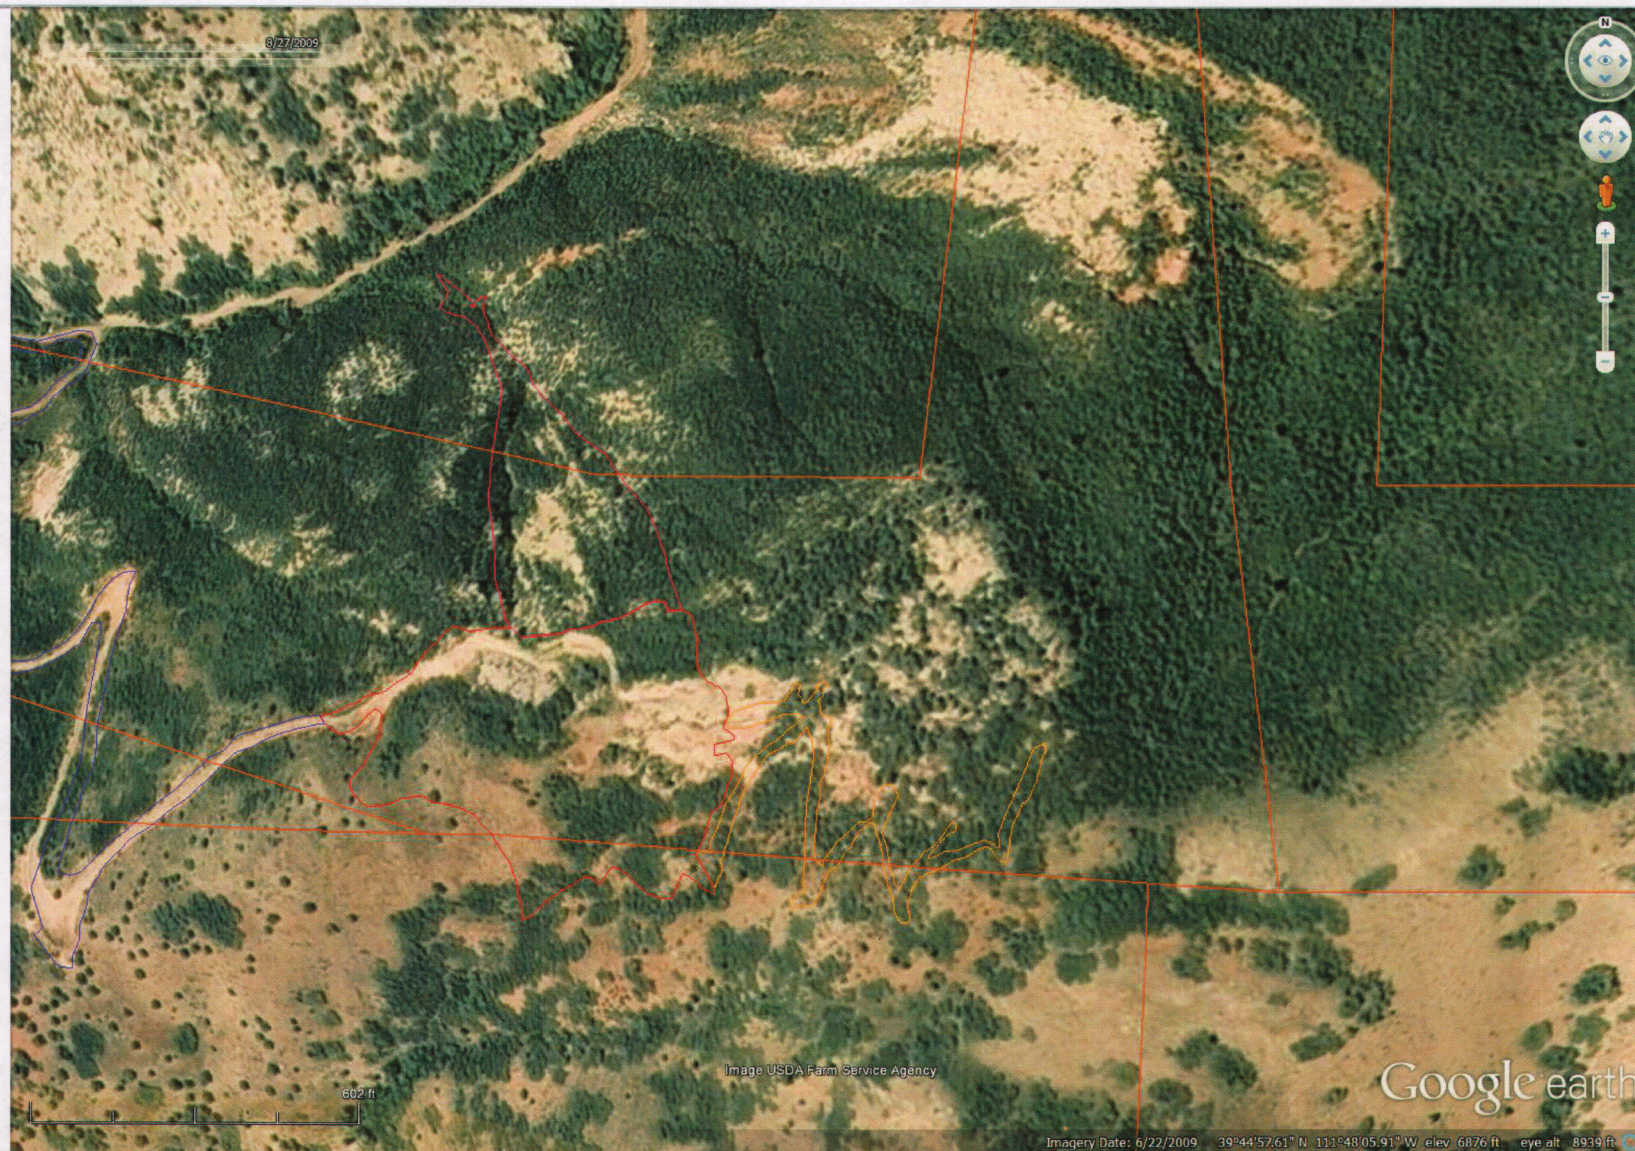
GoogleEarth Image August 27, 2009, there is not road east of the pit.

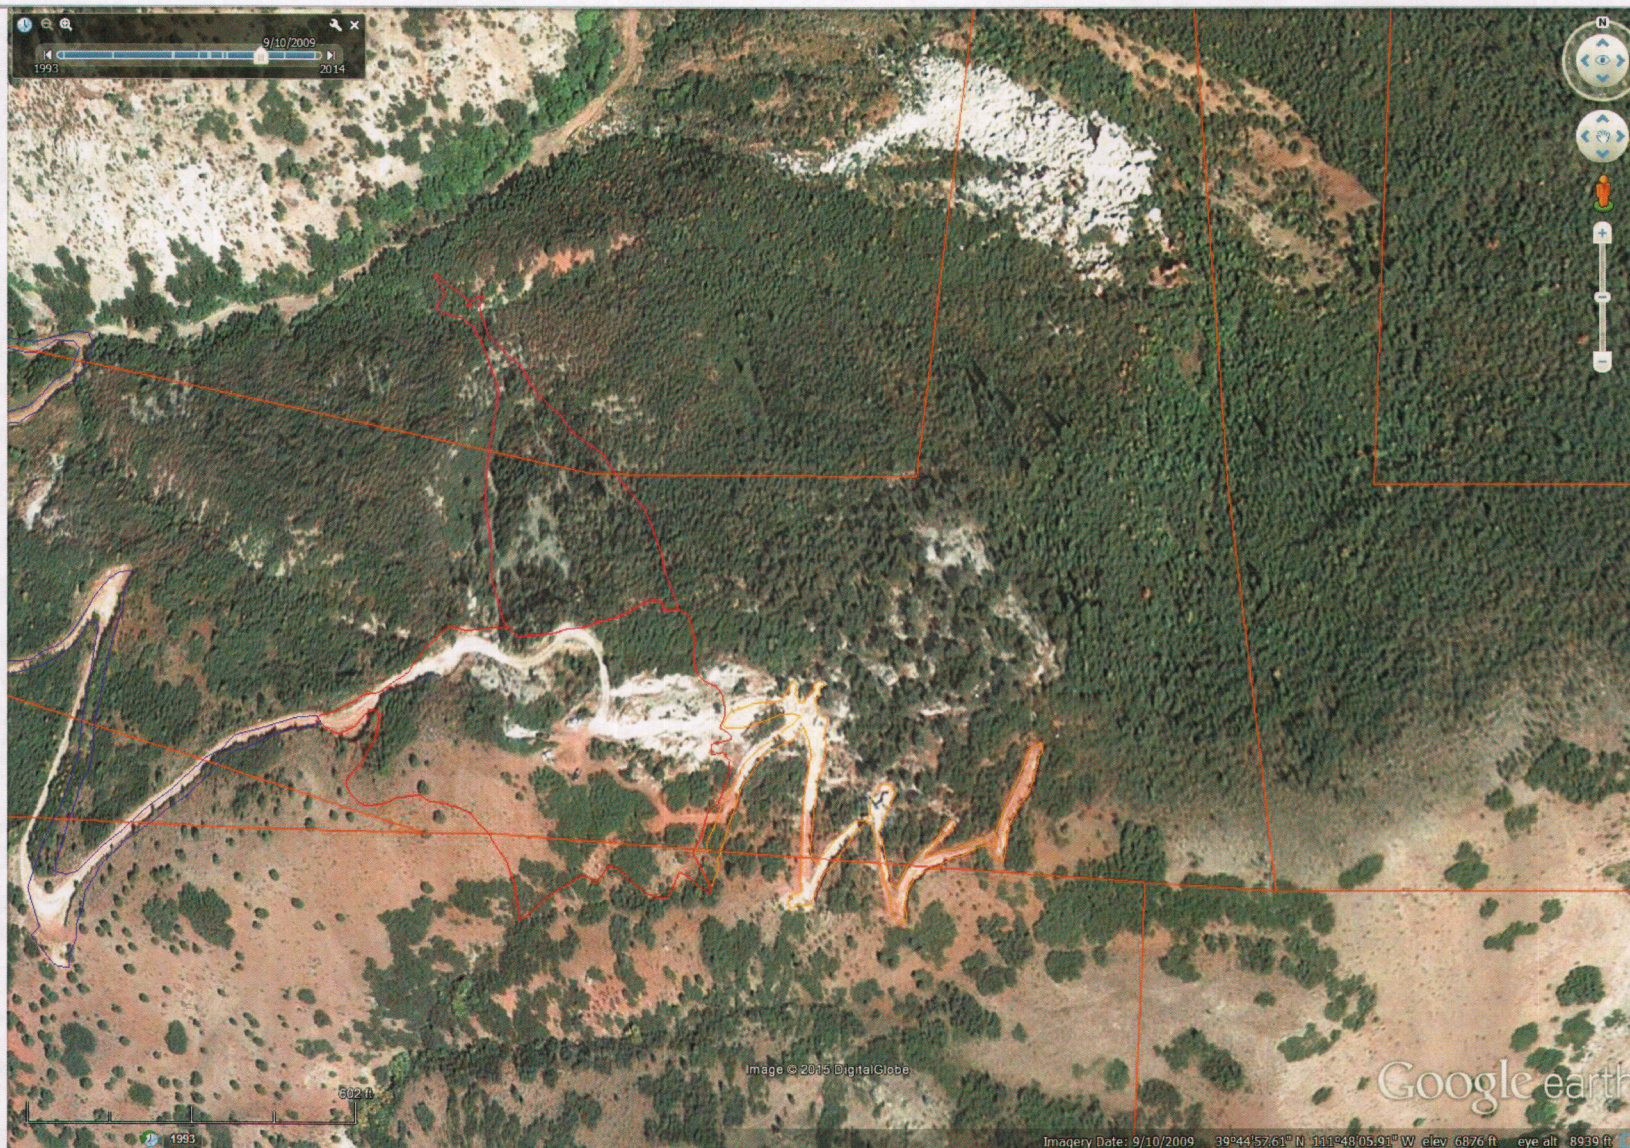
GoogleEarth Image September 10, 2009, there is road east of the pit.

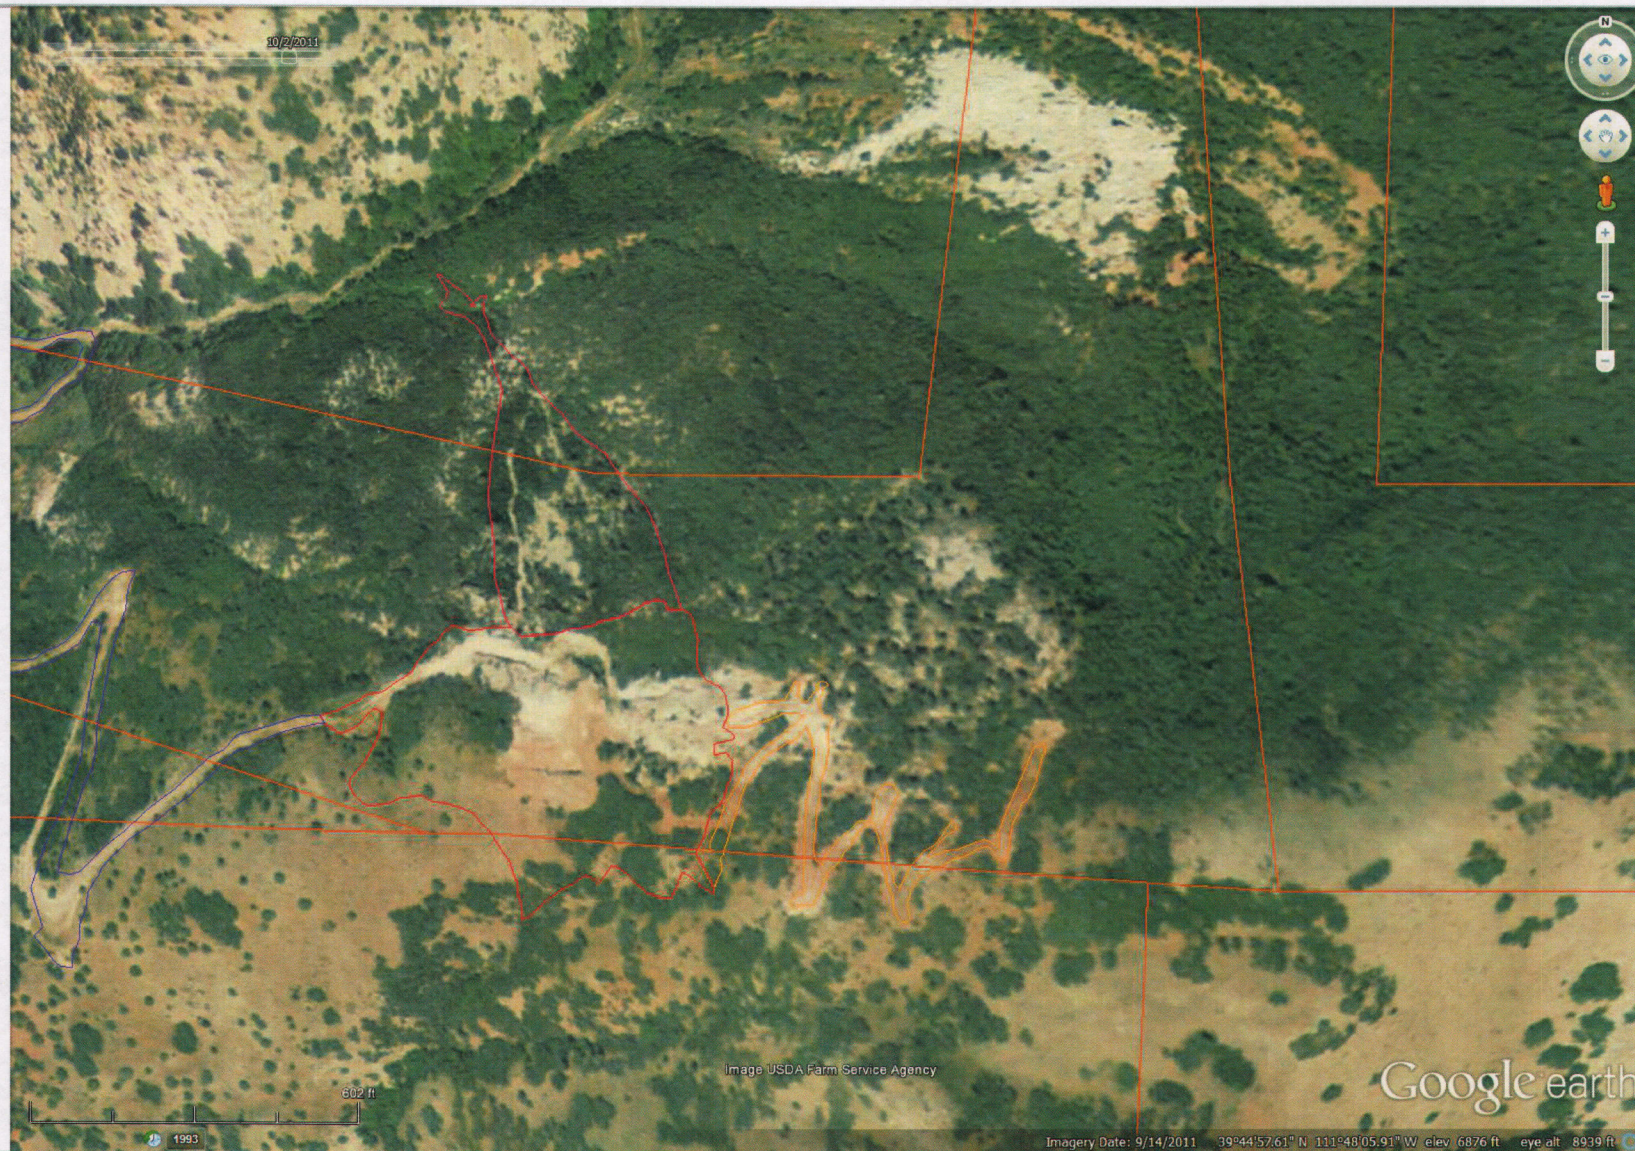
GoogleEarth Image October 2, 2011, note areas north and south of pit

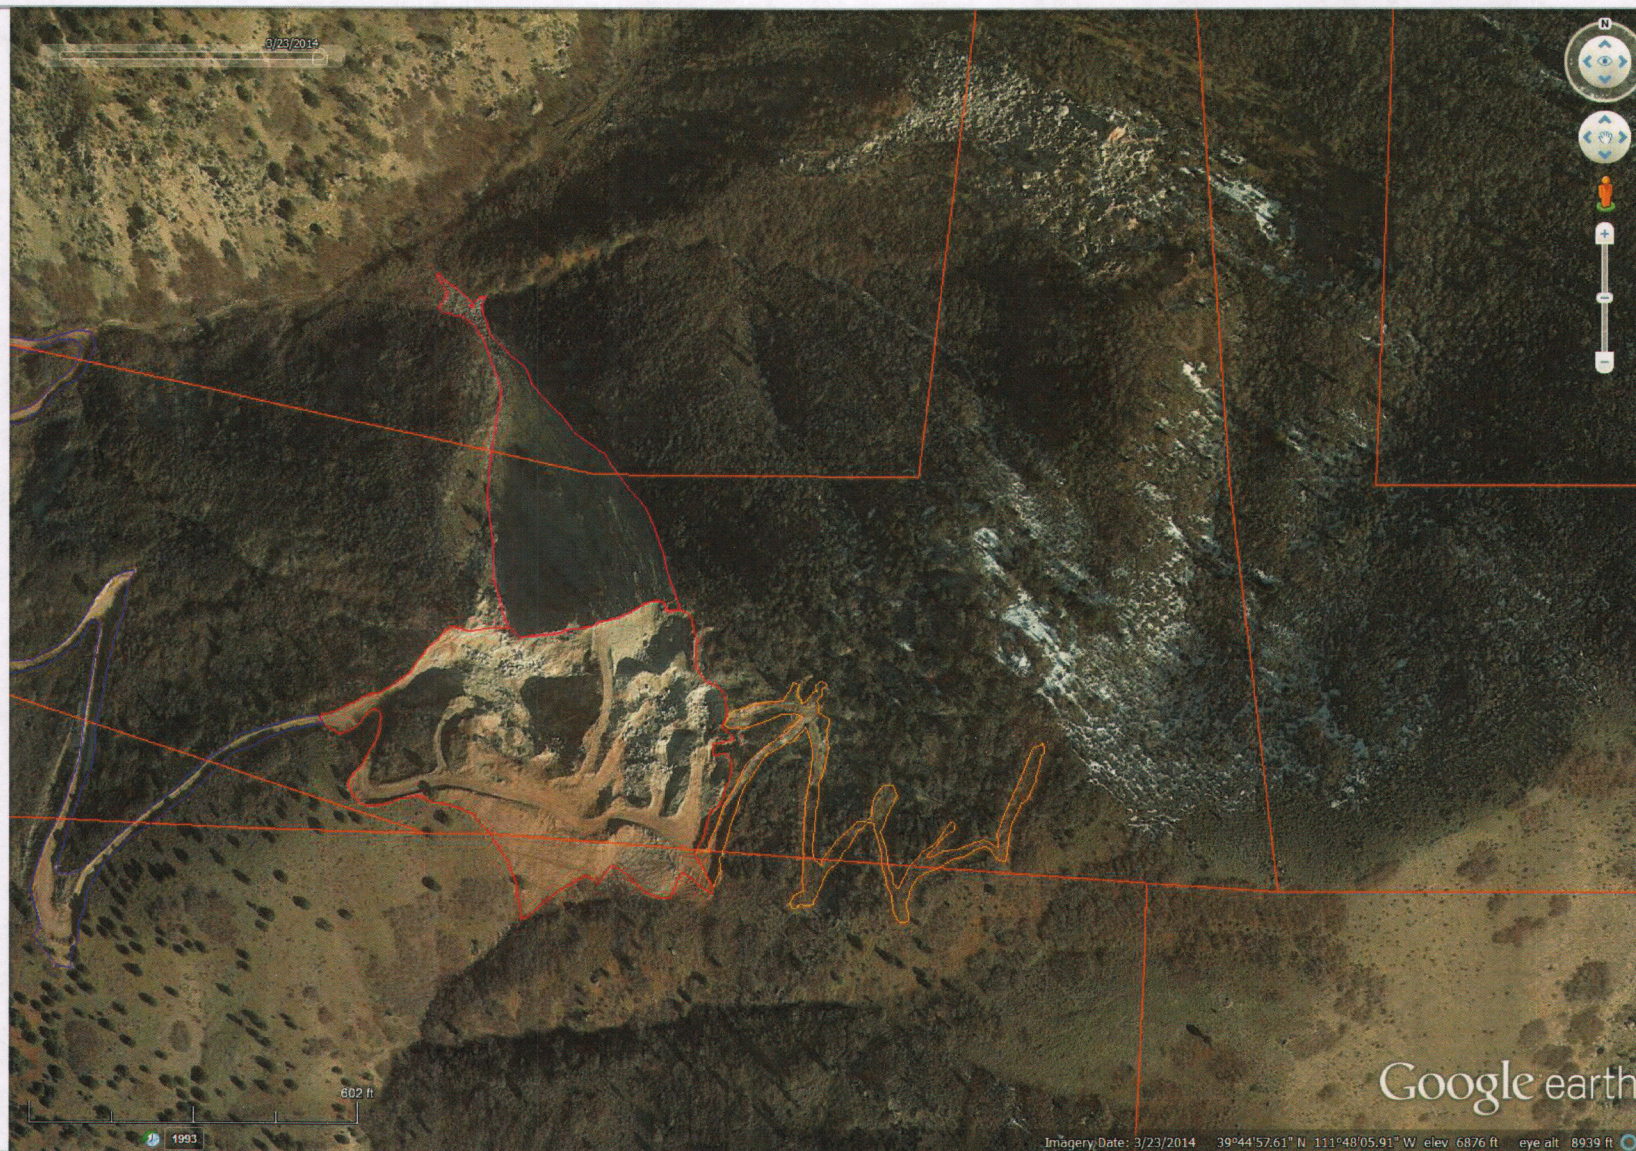
7.	Backfilling/Grading (trenches, pits, roads, highwalls, shafts) The Operator dumped overburden/waste material onto areas outside the disturbed area boundaries. The area north of the disturbed area consists of 2.26 acres which extends from the edge of the disturbed area to the stream channel in Gardner Canyon. The area to the south went on to critical deer and elk winter habitat. The land is owned by the Utah Division of Wildlife resources.	<input checked="" type="checkbox"/>	<input checked="" type="checkbox"/>

The Operator dumped overburden/waste materials onto undisturbed lands north and south of the disturbed area. The area to the north is approximately 2.26 acres. That area is on a slope that is at or near the angle of repose. No soils were salvaged before the material was dumped. Given the steepness of the slope removal of the material and recovery of the soils is not practical. The area to the south also had overburden/waste material dumped onto soils. Remove of the material and recovery of the soils may be possible.

GoogleEarth Image March 23, 2014 - major disturbance to north of pit, some disturbance south of pit and road east of pit reclaimed.
